NDE of Structural Ceramics

Stanley J. Klima and Alex Vary
Lewis Research Center
Cleveland, Ohio

Prepared for the
31st International Gas Turbine Conference
sponsored by the American Society of Mechanical Engineers
Dusseldorf, West Germany, June 8-12, 1986

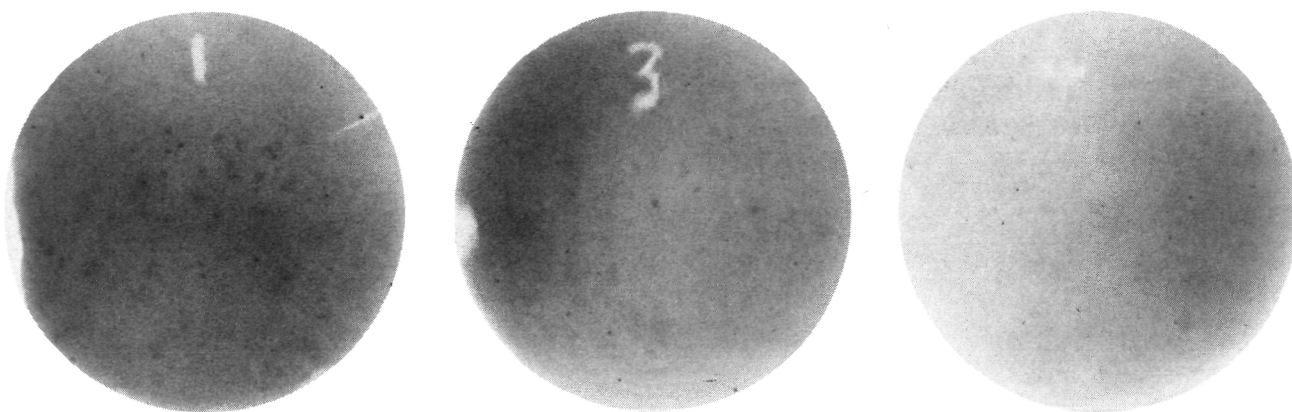
Figure 3. - Radiographs of as-received Si₃N₄ powder showing high density inclusions (dark specks). Disks were made by lightly compacting dry powder in a die at 56 MPa to a final thickness of 3 mm.

Samples of as-received powder were also radiographed to determine if any foreign particles were present prior to in-house processing. Figure 3 shows radiographs of lightly compacted disks which contain numerous high density particles indicating that, other than the oxide additives, most high density inclusions originated during production of the starting powders. Clearly, methods of producing ceramic starting powders must be improved or some method for removing foreign particles must be devised to clean up the powder before making green compacts.

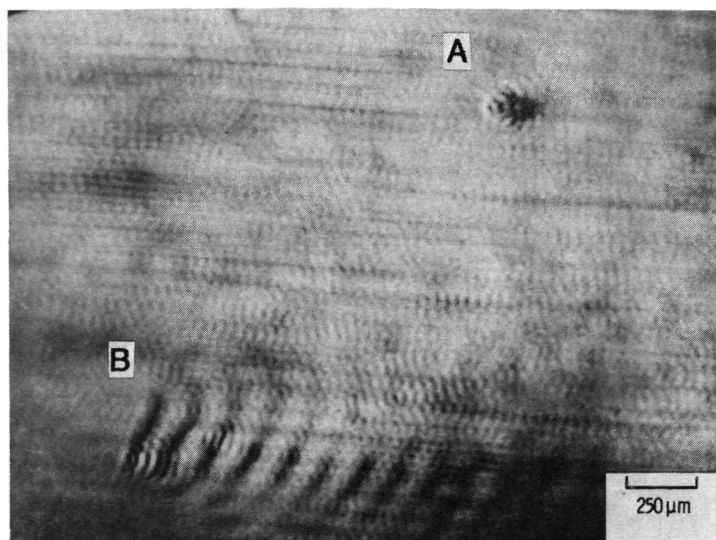
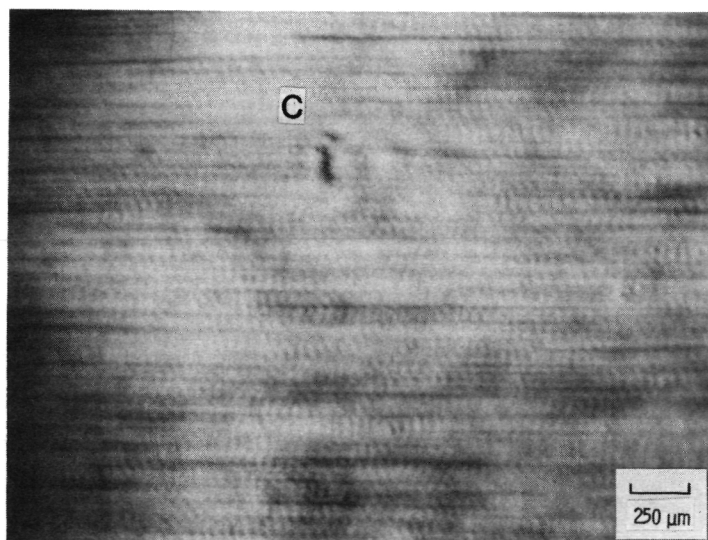
Figure 4. - SLAM micrographs illustrating images of two surface-connected flaws (A and B) and near-surface flaw (c) in diamond-ground silicon nitride specimen.

The scanning laser acoustic microscope (SLAM) was used for detection of surface and near surface defects as well as for revealing patterns of density variations. Figure 4 contains two amplitude mode acoustic micrographs showing three types of defects in silicon nitride. Flaw A is a surface connected inclusion about 75 μm diameter. The same inclusion was detected by x-rays as a high density particle and, since it was surface connected, it could also be seen optically at magnifications of $\times 10$ to $\times 30$. Flaw B is a planar crack-like defect which is also surface connected and could be seen optically. However, it was not detected by x-rays because it is essentially two-dimensional and not oriented exactly parallel to the x-ray beam, and therefore not resolved on the radiograph. Flaw C is also a crack-like feature but is situated beneath the surface. Although it was easily detected by the SLAM, it could not be resolved by either radiographic or optical methods. In addition to the discrete defects just described, the SLAM images also exhibit a background consisting of long straight linear indications caused by diamond grinding grooves, and small ripples not associated with any obvious feature. It is probable that the tiny ripples are caused by microstructural features which diffract the general sound field but are too small and too numerous to be resolved individually. More work is required to determine the nature of these very small scattering sites and what effect they may have on ceramic material properties.

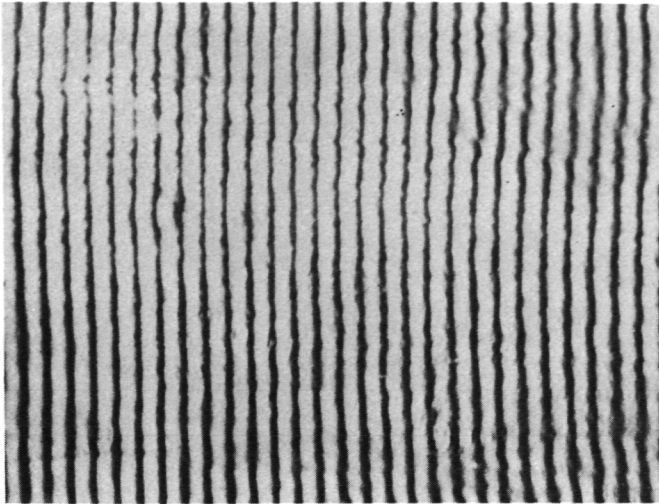
(a) Density is essentially uniform.

Figure 5. - Interferograms produced by the scanning laser acoustic microscope illustrating a capability for imaging density gradients in Si_3N_4 MOR bars.

Scanning laser acoustic microscopy can also be used in the interference mode (8) to obtain information regarding bulk density variations. In a specimen with constant thickness, the time of travel of an ultrasonic wave provides a measure of sound velocity, and velocity can be used to infer material density (9). SLAM interferograms can be used to image velocity variations that occur within the viewing field as shown in Fig. 5. Any deviation in time of travel will cause the interference fringes to bend to the right or left. The relatively straight fringes in Fig. 5(a) imply that, within the field of view (2.75 by 2.0 mm), the density of the ceramic specimen is relatively uniform. In Fig. 5(b) however, the density at the bottom (near the edge of the MOR bar) is significantly greater than at the top

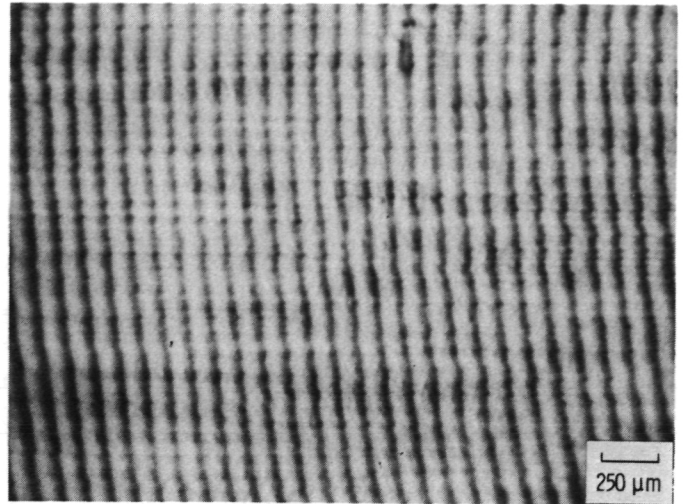
(b) Density increases top to bottom.

of the image which is located a little over 2 mm away from the specimen edge.

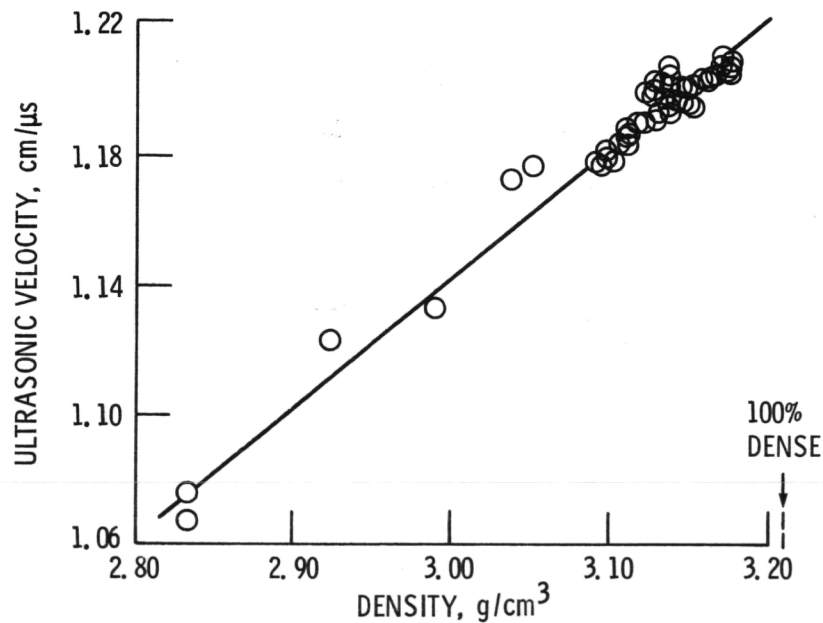
Figure 6. - Relationship between ultrasonic velocity and density of alpha silicon carbide. Data for material in as sintered and hot isostatically pressed conditions, and three grain sizes (Klima et al, 1981).

Ultrasonic velocity and attenuation measurements were used to characterize density and microstructure in monolithic silicon nitride and silicon carbide. Research samples exhibiting a wide range of density and microstructural variations were used to demonstrate that bulk density variations correlate with and can be estimated by velocity measurements (Fig. 6). Variations in microstructure (grain size and shape or void size and distribution) in silicon carbide had only a slight effect on velocity (9). Although significant variations in certain microstructural features had only a slight effect on ultrasonic velocity it was observed that the same variations had a profound effect on attenuation of high frequency ultrasonic waves. Figure 7 shows a plot of attenuation as a function of ultrasonic frequency for some of the same specimens used in the velocity-density study. Eight silicon carbide samples, all with similar bulk densities were selected. The specimens were divided equally into sets with two widely differing microstructures as shown in Fig. 7. The plot shows that attenuation in the large grained material is at least four times higher than for the small grained material. Although the grain size is the most obvious microstructural difference between the two sample groups, there also exist other features that could affect ultrasonic attenuation as well as material properties. For example, the less attenuating material has equiaxed grains while many grains in the more attenuating material are elongated or rod-like in shape. The void size and morphology is also quite different. Although the total porosity is the same for the two sample groups as evidenced by the measured bulk density, the photomicrographs show that voids are larger but fewer in number in the more attenuating material. It is probable that all of the variations in microstructure just described have a cumulative effect on total measured attenuation in the ceramic samples. It is not clear which feature has the greatest effect at this time because the variables cannot be readily separated during thermomechanical processing of the materials.

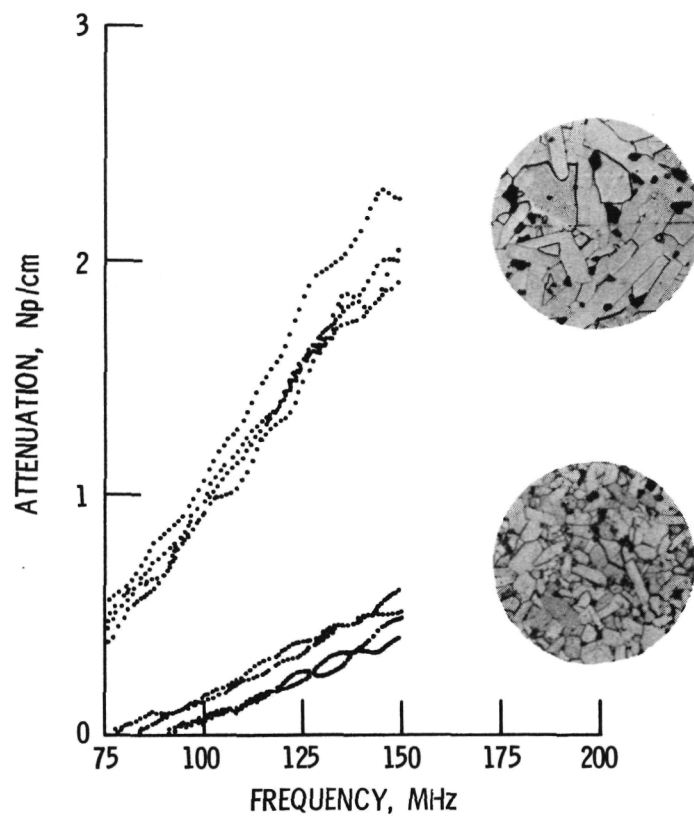
Figure 7. - Effect of microstructure on ultrasonic attenuation in sintered alpha silicon carbide. Bulk density, 3.11 to 3.12 g/cm³.

Modulus of rupture test results from the samples show that the material with the fine microstructure is significantly stronger at room temperature than the coarser material. This suggests that ultrasonic attenuation measurements may be useful as a quality control tool to assure material strength to the extent that is controlled by microstructure. It should be noted however, that such a relationship may be valid only as long as composition is unchanged. For example, the authors of Ref. 10 reported MOR results for silicon nitride with four different rare-earth additives. The composition that yielded the highest strength also exhibited the largest grain size. Obviously more work is needed in this area.

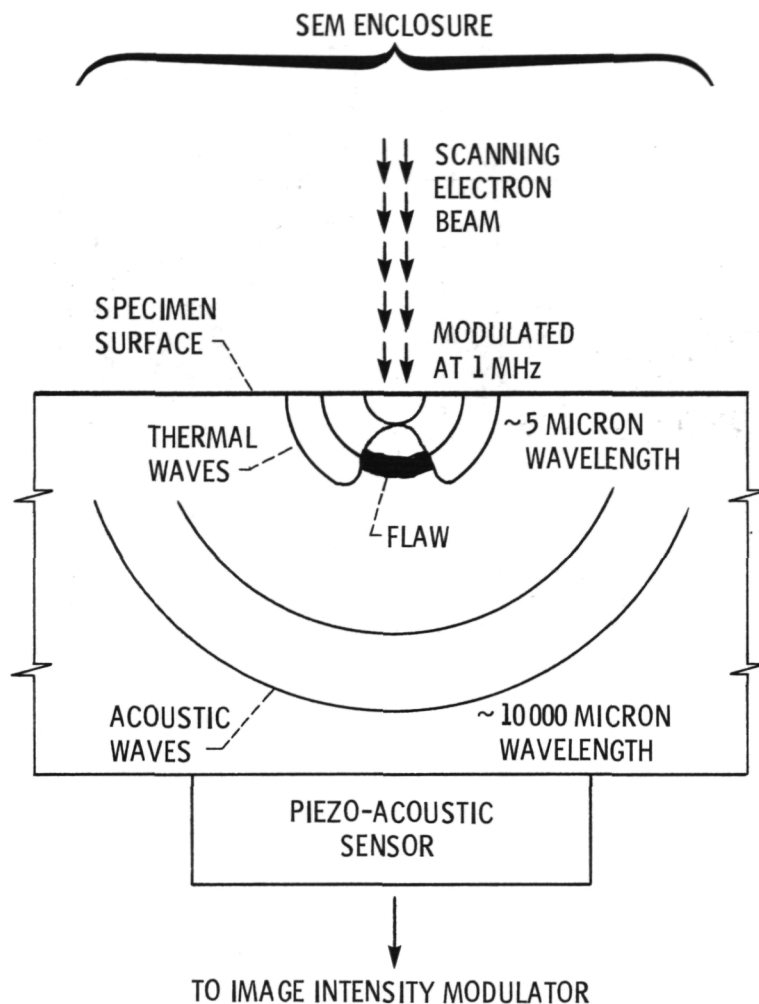
Figure 8. - Schematic representation of a thermo-acoustic device utilizing an electron beam source and an ultra-sonic sensor housed in a scanning electron microscope enclosure.

A schematic diagram of a system utilizing a scanning electron beam heating source and a piezo-electric acoustic sensor contained in a scanning electron microscope envelope is shown in Fig. 8. Figure 9 contains a SEM backscatter image alongside a thermo-acoustic image of the same region near the edge of a silicon carbide specimen. The SEM image shows a portion of a crack that originates at the edge, as well as dust particles on the specimen surface. The thermo-acoustic image clearly shows the subsurface extension of the crack in addition to the optically visible portion. Note, however, that the surface dust was not registered by the thermo-acoustic interrogation. Thus, the thermo-acoustic technique shows promise for detection of surface and near-surface discontinuities in ceramics.

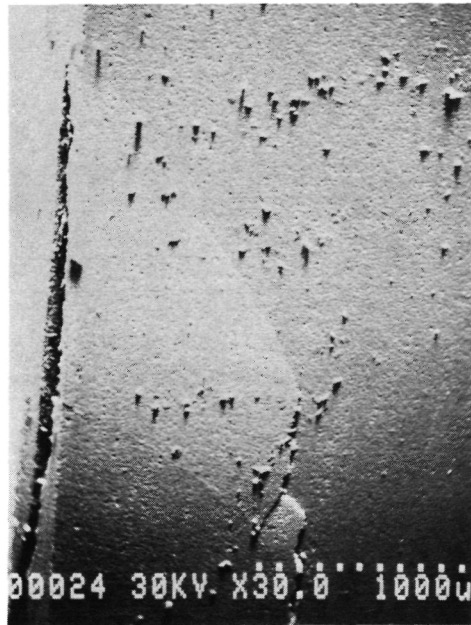
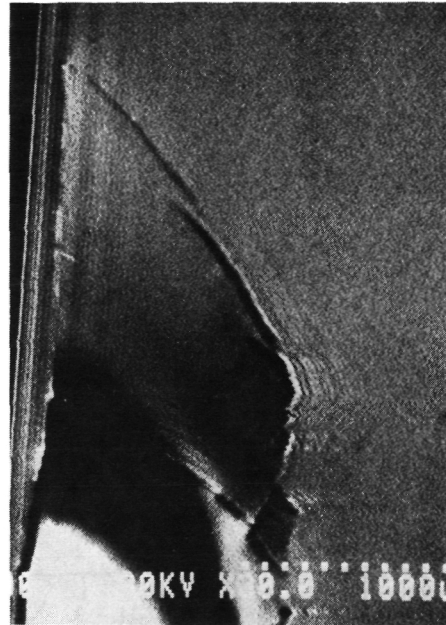
(a) SEM backscatter image.

(b) Thermo-acoustic image.

Figure 9. - Images of a spall crack near the edge of a silicon carbide MOR bar obtained by a conventional SEM technique and by thermo-acoustic microscopy (TAM). TAM reveals subsurface cracking not shown by SEM. Dust visible in the SEM image was ignored by TAM.

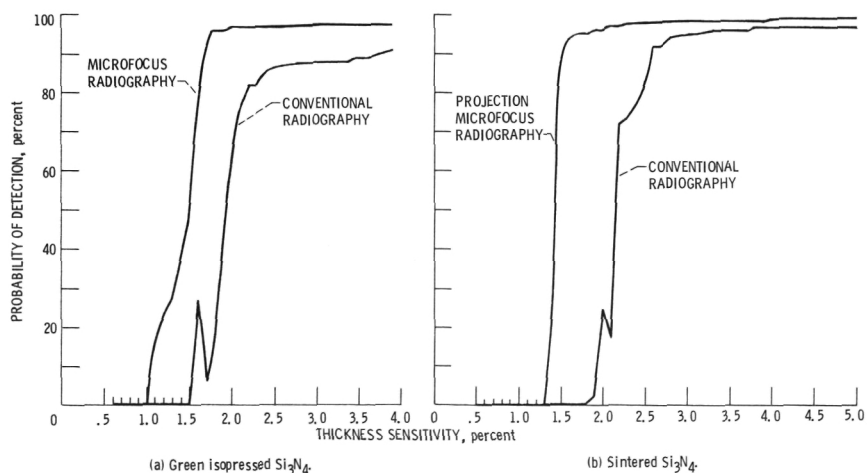
Figure 10. - Lower bound probability of detection of surface voids in Si_3N_4 bars calculated at 95 percent confidence level. Thickness sensitivity = (void dimension in x-ray beam direction)/(thickness of specimen in same direction). (Baakini, et al)

An example of NDE reliability data generated for SLAM and radiographic techniques, according to the guidelines set forth in Ref. 15, is presented in Figs. 10 and 11 in the form of plots of probability of detection as a function of void size. The curves

define the lower limit of probability of detection (a conservative estimate) calculated at a confidence level of 95 percent using the binomial distribution. Details are given in Refs. 16 and 17. The significance of reliability data is that it provides information regarding the size of flaws that can be detected with a reasonable degree of reliability. For example, Fig. 10(b) shows that the probability of detection is 90 percent or higher for void diameters equal to or greater than 1.5 percent of specimen thickness when using the microfocus x-ray technique. For conventional radiography similar probabilities of detection are indicated only for voids exceeding 2.5 percent of specimen thickness. The plots also show that smaller voids can sometimes be detected, but with lower detection reliability. For SLAM technique, the plot (Fig. 11) shows that detectability is significantly improved by polishing the specimen surface. Thus, the designer must take into consideration the surface finish of a component in order to assure that it is inspectable. The designer can utilize this type of data to determine the largest flaw that will be missed a significant proportion of time, and take steps to ensure that operating stresses are adequate to prevent that size flaw from becoming critical. Very little data of this type exists today, particularly for structural ceramics. All too often, the smallest detectable flaw sizes are reported for specific techniques with no regard to the probabilistic nature of the NDE process.

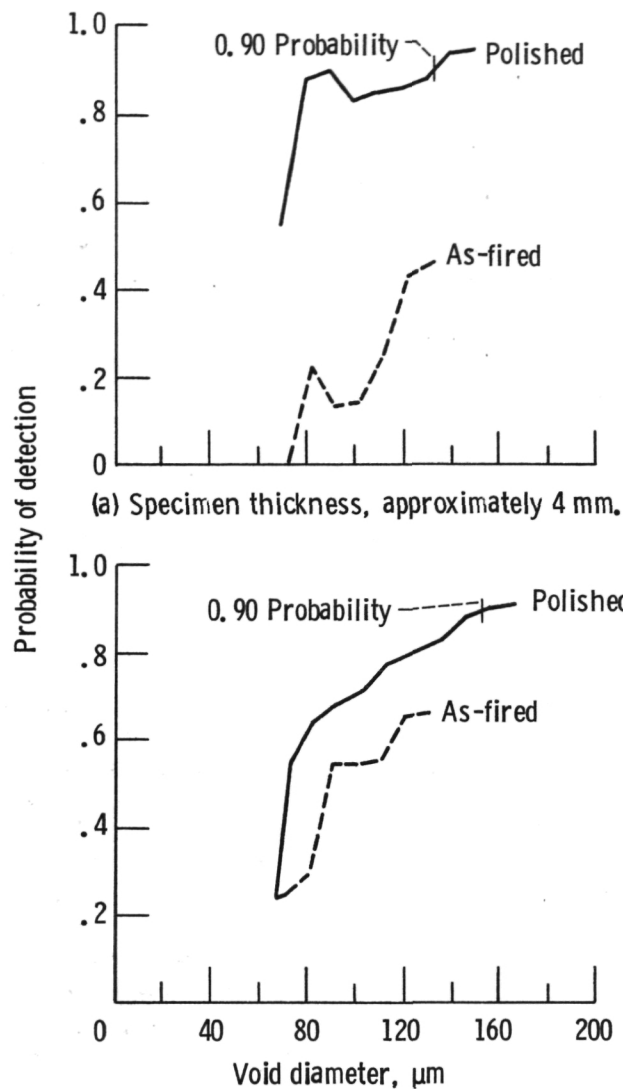
(b) Specimen thickness, approximately 3 mm.

Figure 11. - Probability of detection of voids in sintered silicon nitride specimens showing improvement in void detectability after hand polishing. Probability of detection calculated at 0.95 confidence level. (Roth, et al)
